Manhole Inspection Summary

Manhole # S13EE_021MH

Insp Date: **9/20/07 1:49 PM**

Location Address: **REAR 2844 ELLICOT DWY**

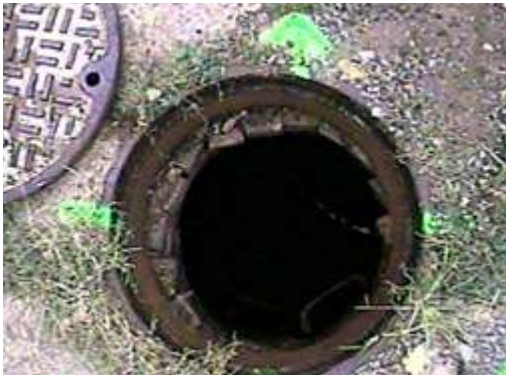
Top View

FRAME OFFSET

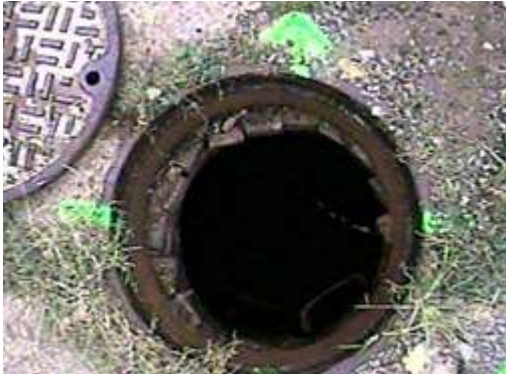
Defect 1

CORRODED STEP

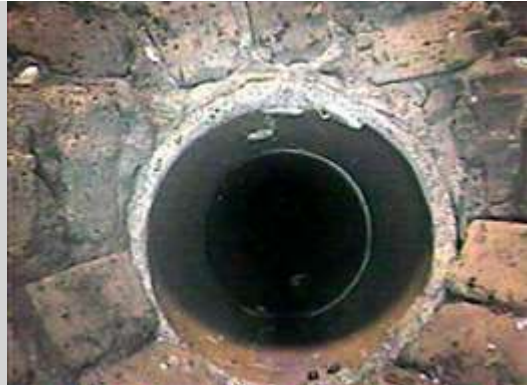
12 O'Clock Outflow

8 in. Circular Gravity Sewer
Pipe Out @ 12 O'Clock

Invert Depth: **7.18** (ft.) Flow Characteristics: **Slow**

Infiltration: **None** Pipe Seal Cond: **Sound**

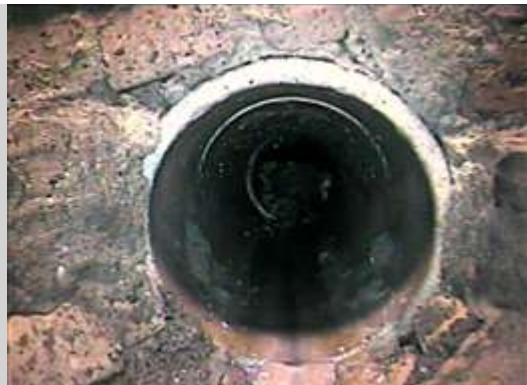
3 O'Clock Inflow

8 in. Circular Gravity Sewer
Pipe In @ 3 O'Clock

Invert Depth: **6.99** (ft.) Flow Characteristics: **Slow**

Infiltration: **None** Pipe Seal Cond: **Sound**

Connects To: **Stub connection / abandoned**

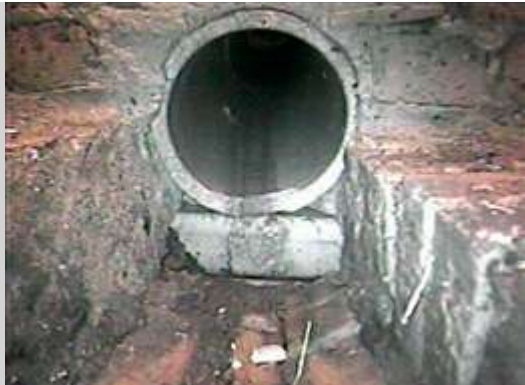
6 O'Clock Inflow

6 in. Circular Gravity Sewer

Pipe In @ 6 O'Clock

Pipe Seal Cond: **Cracked**

Connects To: **House connection / Service line**

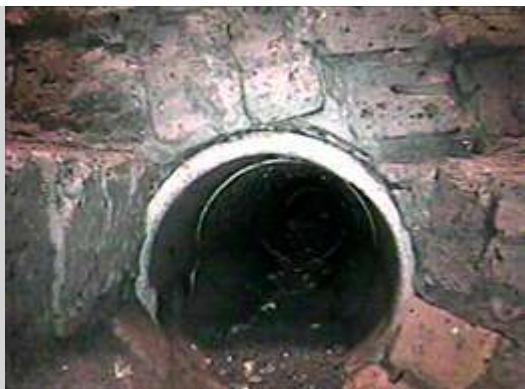
9 O'Clock Inflow

8 in. Circular Gravity Sewer

Pipe In @ 9 O'Clock

Deposits: ☐ None ☐ Mud ☐ Sludge ☒ **Debris** ☐ Grease

Silt Depth: **0.5** (in.) Deposits Extent: **Light**

Connects To: **Stub connection / abandoned**
